# Evaluation Of The Silver Tarnish Problem, Launch Processing System

TEST REPORT

National Aeronautics and Space Administration  
Kennedy Space Center  
Materials Testing Branch

The Materials Testing Branch was requested to evaluate the effects of silver "tarnishing" of components of the Launch Processing System. The area of most significant concern found is the "tarnish" effects on the wire-wrap wires of the older LPS circuit boards. If maintained in the proper environment the LPS hardware could be expected to have a significantly extended operational life, despite the relatively poor quality of some hardware.

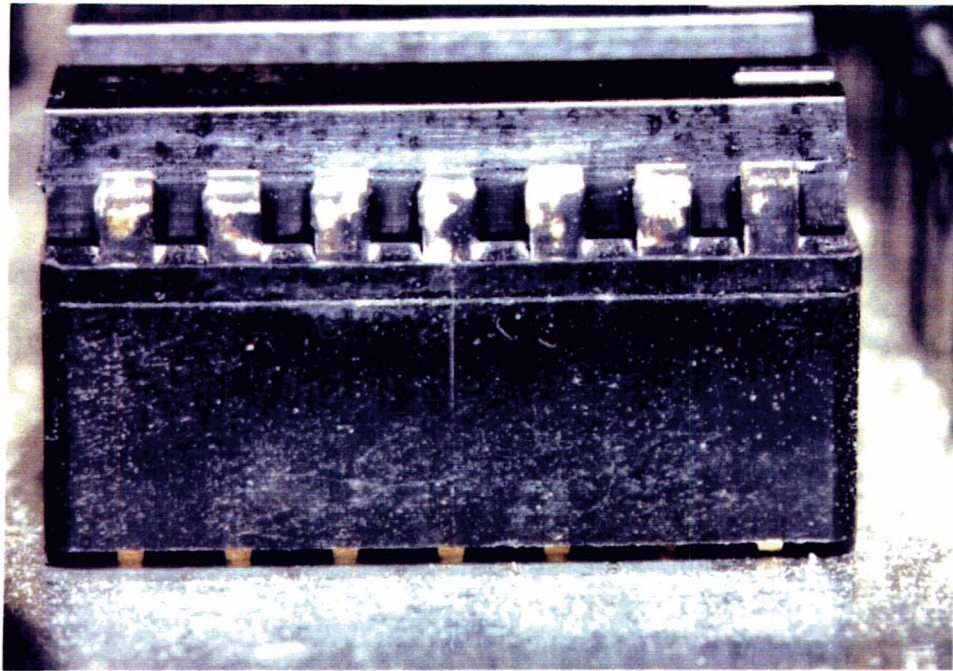
FIGURE 4-3

4.1.2 The pin leads on many of the IC's were tarnished (see Figure 4-3). The exposed wire-wrap wires were found to have varying shades of discoloration (tarnish) on the exposed wire (see Figure 4-4). There was

AN IC WITH TARNISHED (BLACKENED) SILVER LEADS (PINS) ON BOARD NO. 1 IS SHOWN. ENVIRONMENTAL DEBRIS IS EVIDENT ON THE BOARD AND THE SIDE OF THE BLACK BODY SOCKET.

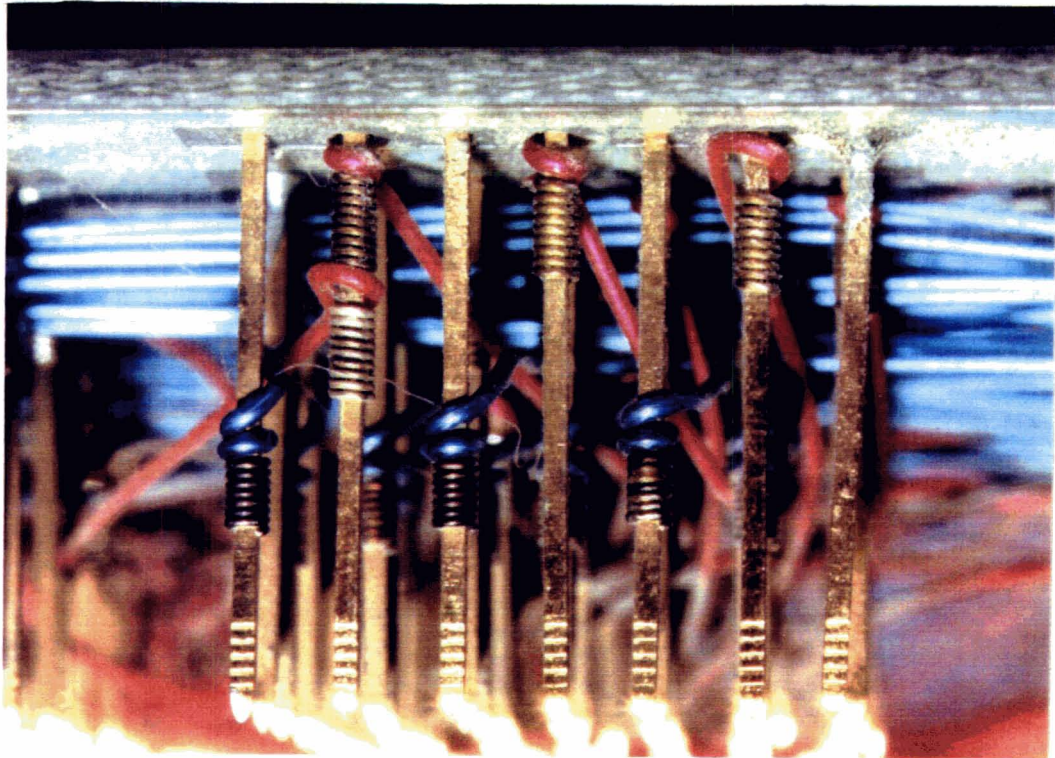
FIGURE 4-4

WIRE-WRAPPS ON BOARD NO. 1 ARE SHOWN. THE EXPOSED WIRES RANGED IN COLOR FROM SILVER THROUGH GOLDEN TO BLACK. ENVIRONMENTAL DEBRIS IS EVIDENT ON SEVERAL POSTS WHERE THEY PENETRATE THE BOARD.

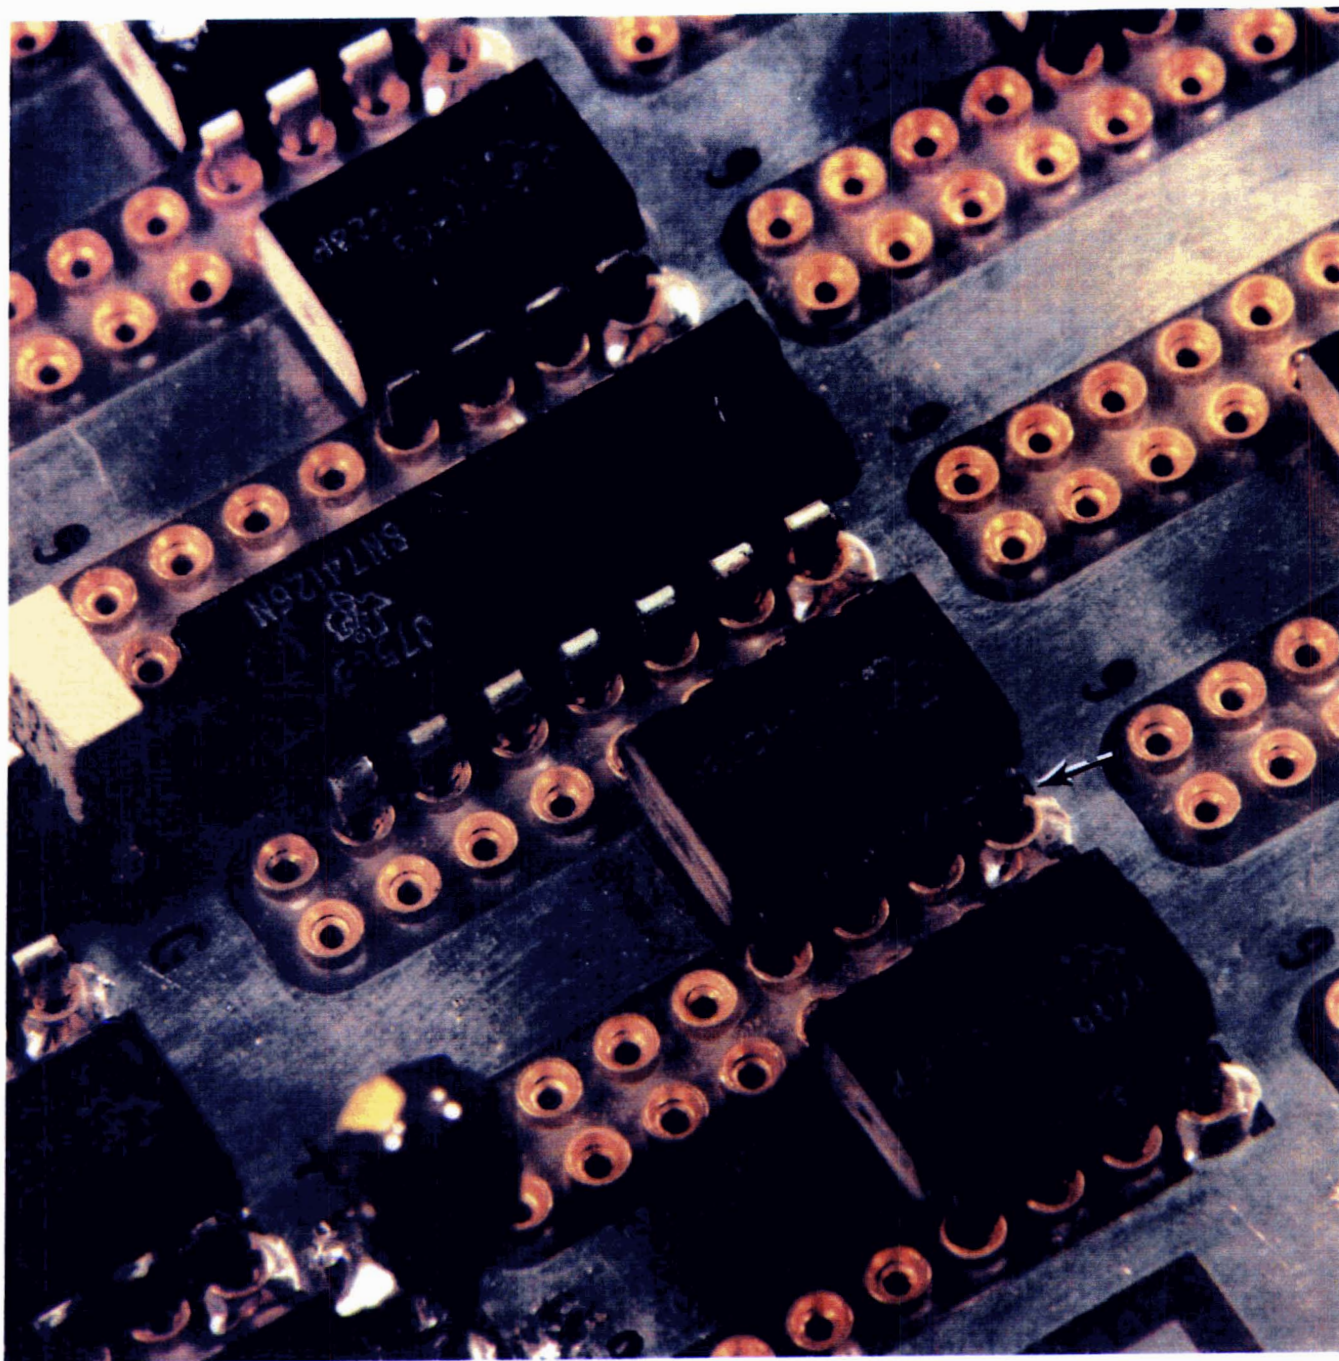
FIGURE 4-7

THE SOCKET/POSTS ARE AN INTEGRAL PART OF BOARD NO. 3.  
THE SILVER PLATED IC PINS (ARROW) ARE BLACK FROM AN  
INADVERTENT EXPOSURE TO  $H_2S$ .

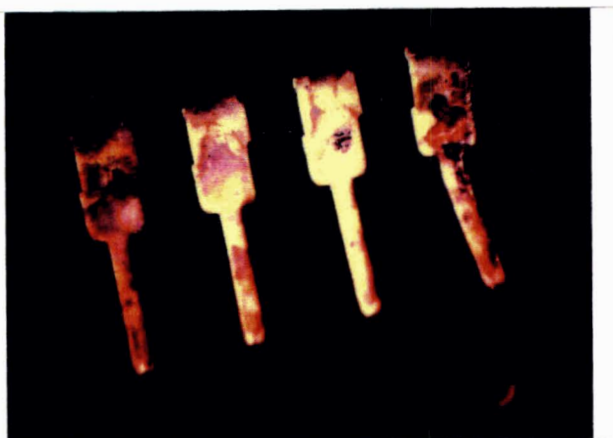
FIGURE 4-8

Two Z80 CPU IC's were removed from stock by the requestors. The pins were found to be tarnished. The discoloration encompassed a rainbow spectrum of colors including black (see Figure 4-8).

4.5.3 SEM/EDS analysis indicated that the base metal of the IC pins to be a high-Ni steel with a trace of Mn. SEM/EDS analysis showed the plating to be Ag with S present. The discoloration is probably  $\text{Ag}_2\text{S}$ , tarnish.

THE DISCOLORED PINS OF A Z80 CPU IC ARE SHOWN.

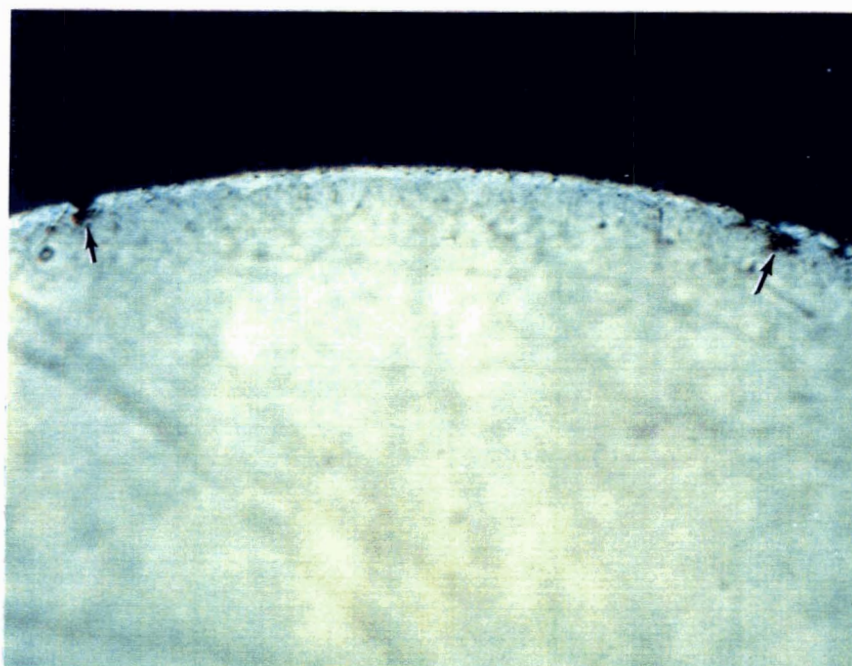
FIGURE 4-13

PHOTOMICROGRAPH OF THE SINGLE AREA 'A' WIRE CROSS-SECTION WHICH SHOWED SIGNS OF CORROSION PENETRATING THE Ag PLATING.

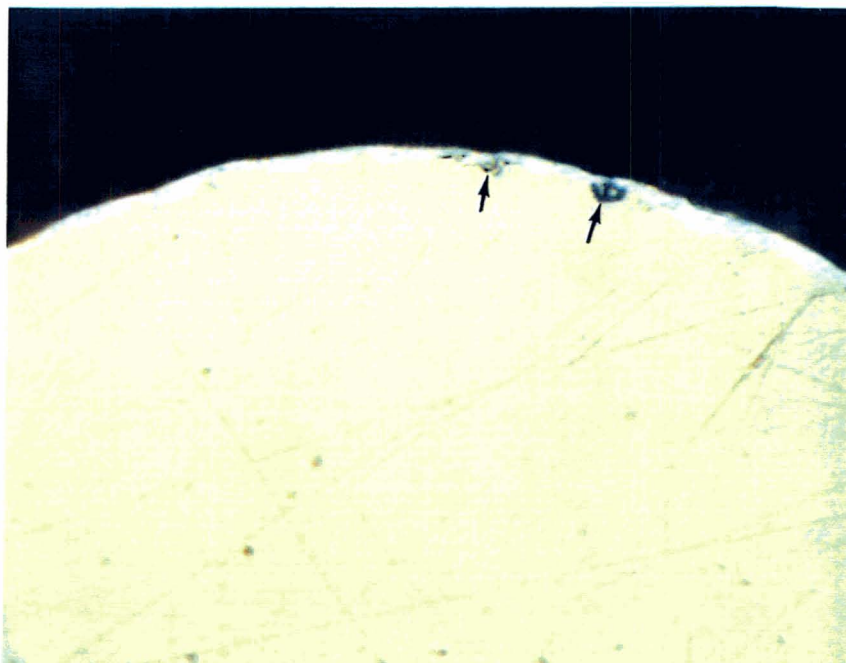
FIGURE 4-14

PHOTOMICROGRAPH OF A TYPICAL AREA 'B' WIRE CROSS-SECTION WHICH SHOWS SIGNS OF CORROSION PENETRATING IN TO THE Cu.

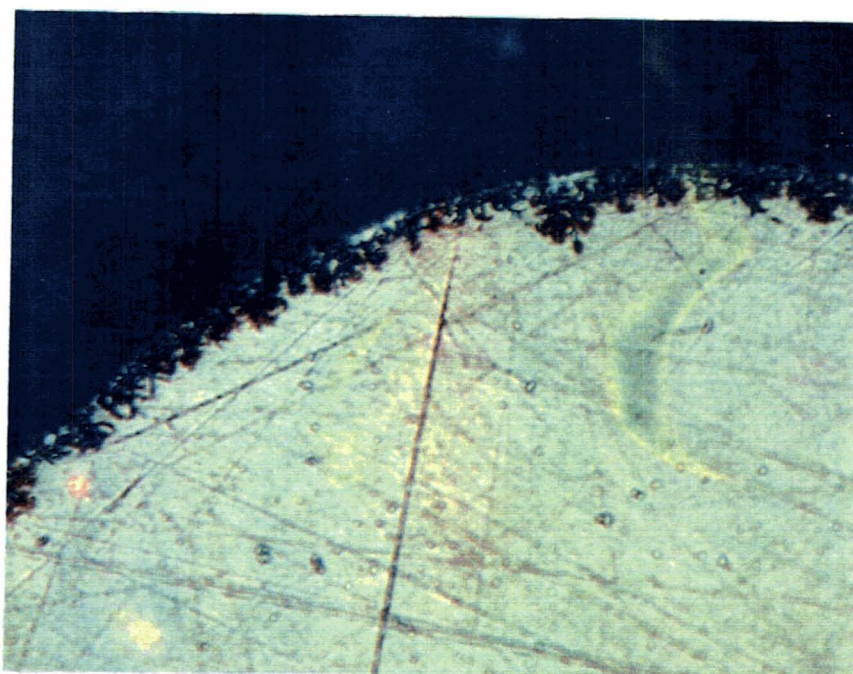
FIGURE 4-15

PHOTOMICROGRAPH OF AN AREA 'C' WIRE CROSS-SECTION WHICH SHOWS GROSS CORROSION PENETRATION INTO THE Cu.

- 7.3.1 The primary area of concern is the effect of sulfides on the wire-wrap wires. In the process of forming the wire-wraps the exposed wires will receive some mechanical damage to the protective Ag coating. Over the long-term, sulfides and oxides will attack the copper beneath the Ag coating through the damaged areas (3).

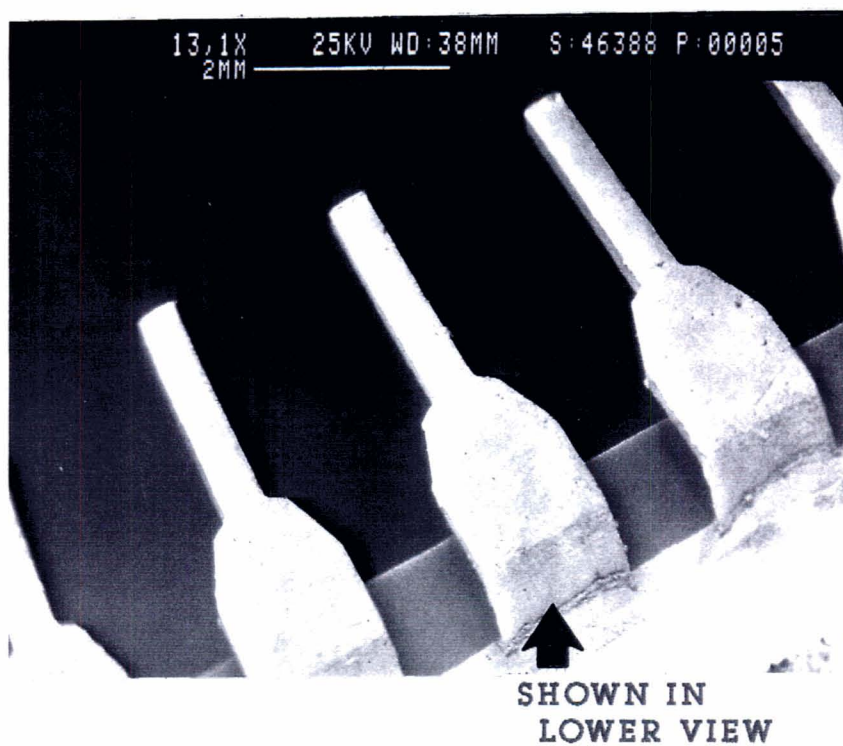
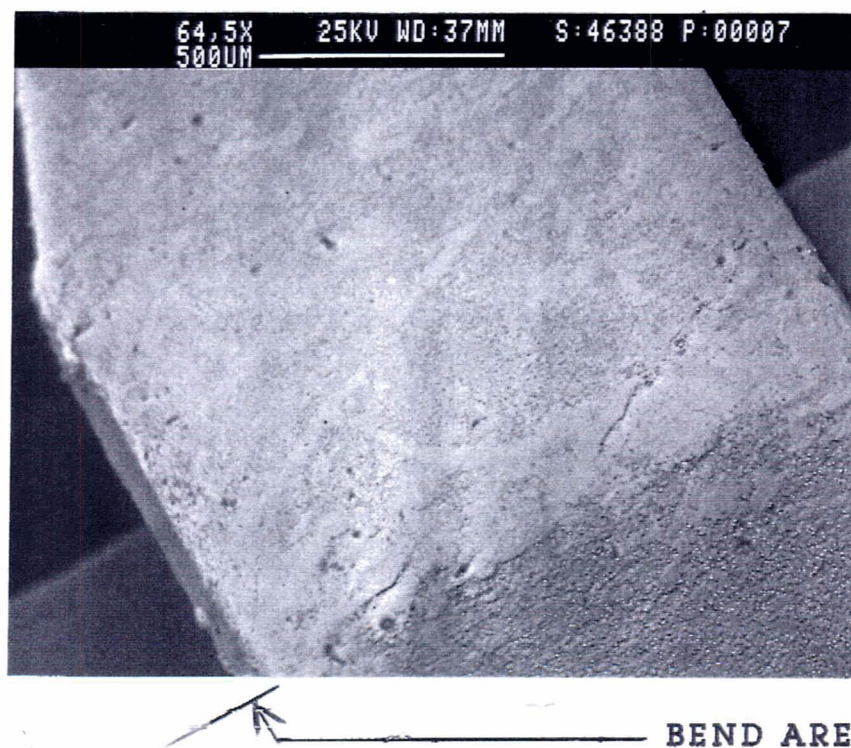
FIGURE 4-16

4.8.1 The pins of an IC from Board No. 2 were examined. The pins from the model number SN54LS170J IC, with a date code of 8122A were a Ni-steel, with a Sn coating (plating). The coating was found to contain only a few minute voids or pits; however, there was some surface roughness in the bend area (see Figure 4-16). The contact area (see Figure 4-17) shows signs of sliding contact, scratches, while some of the adjacent areas show sign of florescence. Florescence in SEM analysis is often a sign of oxidation, corrosion. The contact area face of the pins is relatively flat and perpendicular to the adjacent planes, and it extends the full thickness of the pin.

SEM-PHOTOMICROGRAPHS OF THE Sn PLATED PINS OF IC SN54LS170J, 8122, BOARD NO. 2. SURFACE ROUGHNESS IS EVIDENT IN THE BEND AREA (LOWER VIEW).

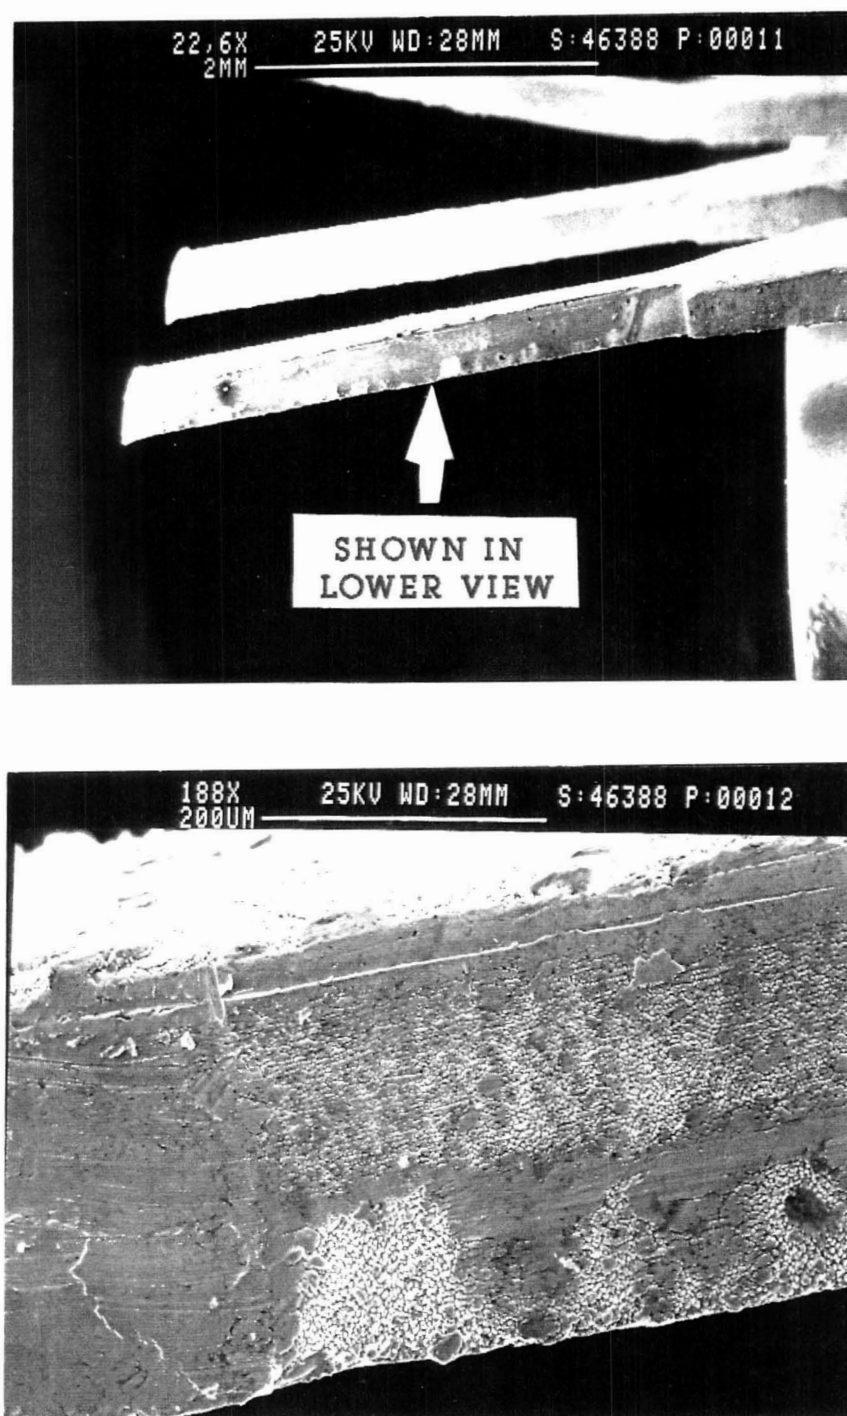
FIGURE 4-17

SEM-PHOTOMICROGRAPHS OF A Sn PLATED PIN CONTACT AREA (ARROW) OF IC SN54LS170J, 8122, BOARD NO. 2. THE CONTACT AREA IS A FLAT SURFACE WHICH TRAVERSES THE THICKNESS OF THE PIN. SOME SCRATCHES ARE EVIDENT FROM INSTALLATION IN AND REMOVAL FROM THE SOCKET.

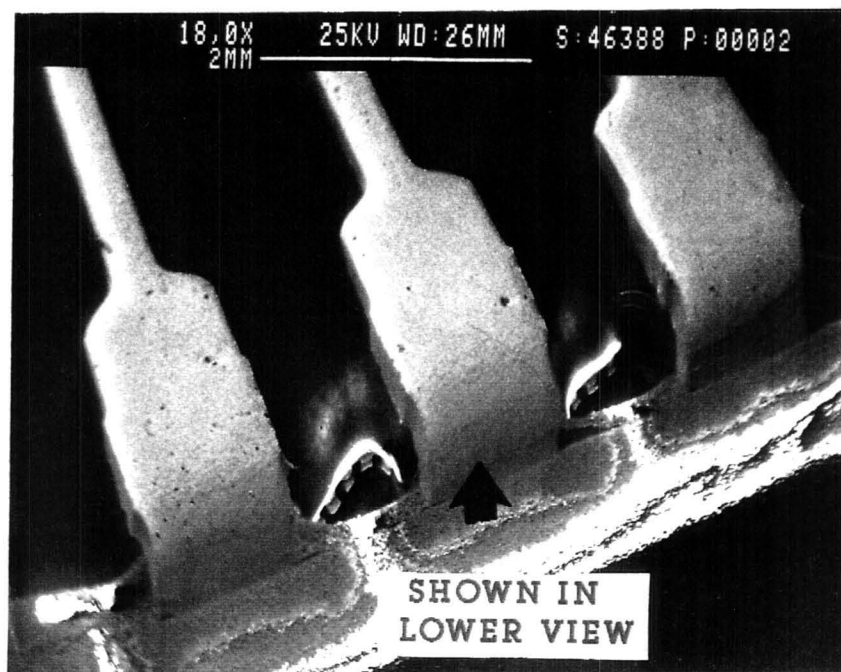
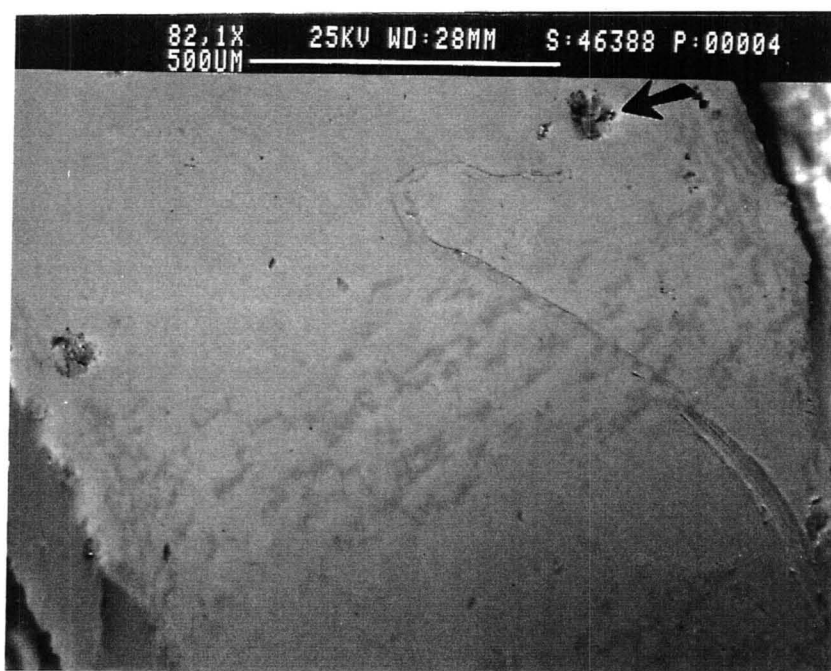
FIGURE 4-18

SEM-PHOTOMICROGRAPHS OF THE Pb-Sn PLATED PINS OF IC  
SN7404N, (8)748. THE PIT (ARROW) CONTAINED S1.

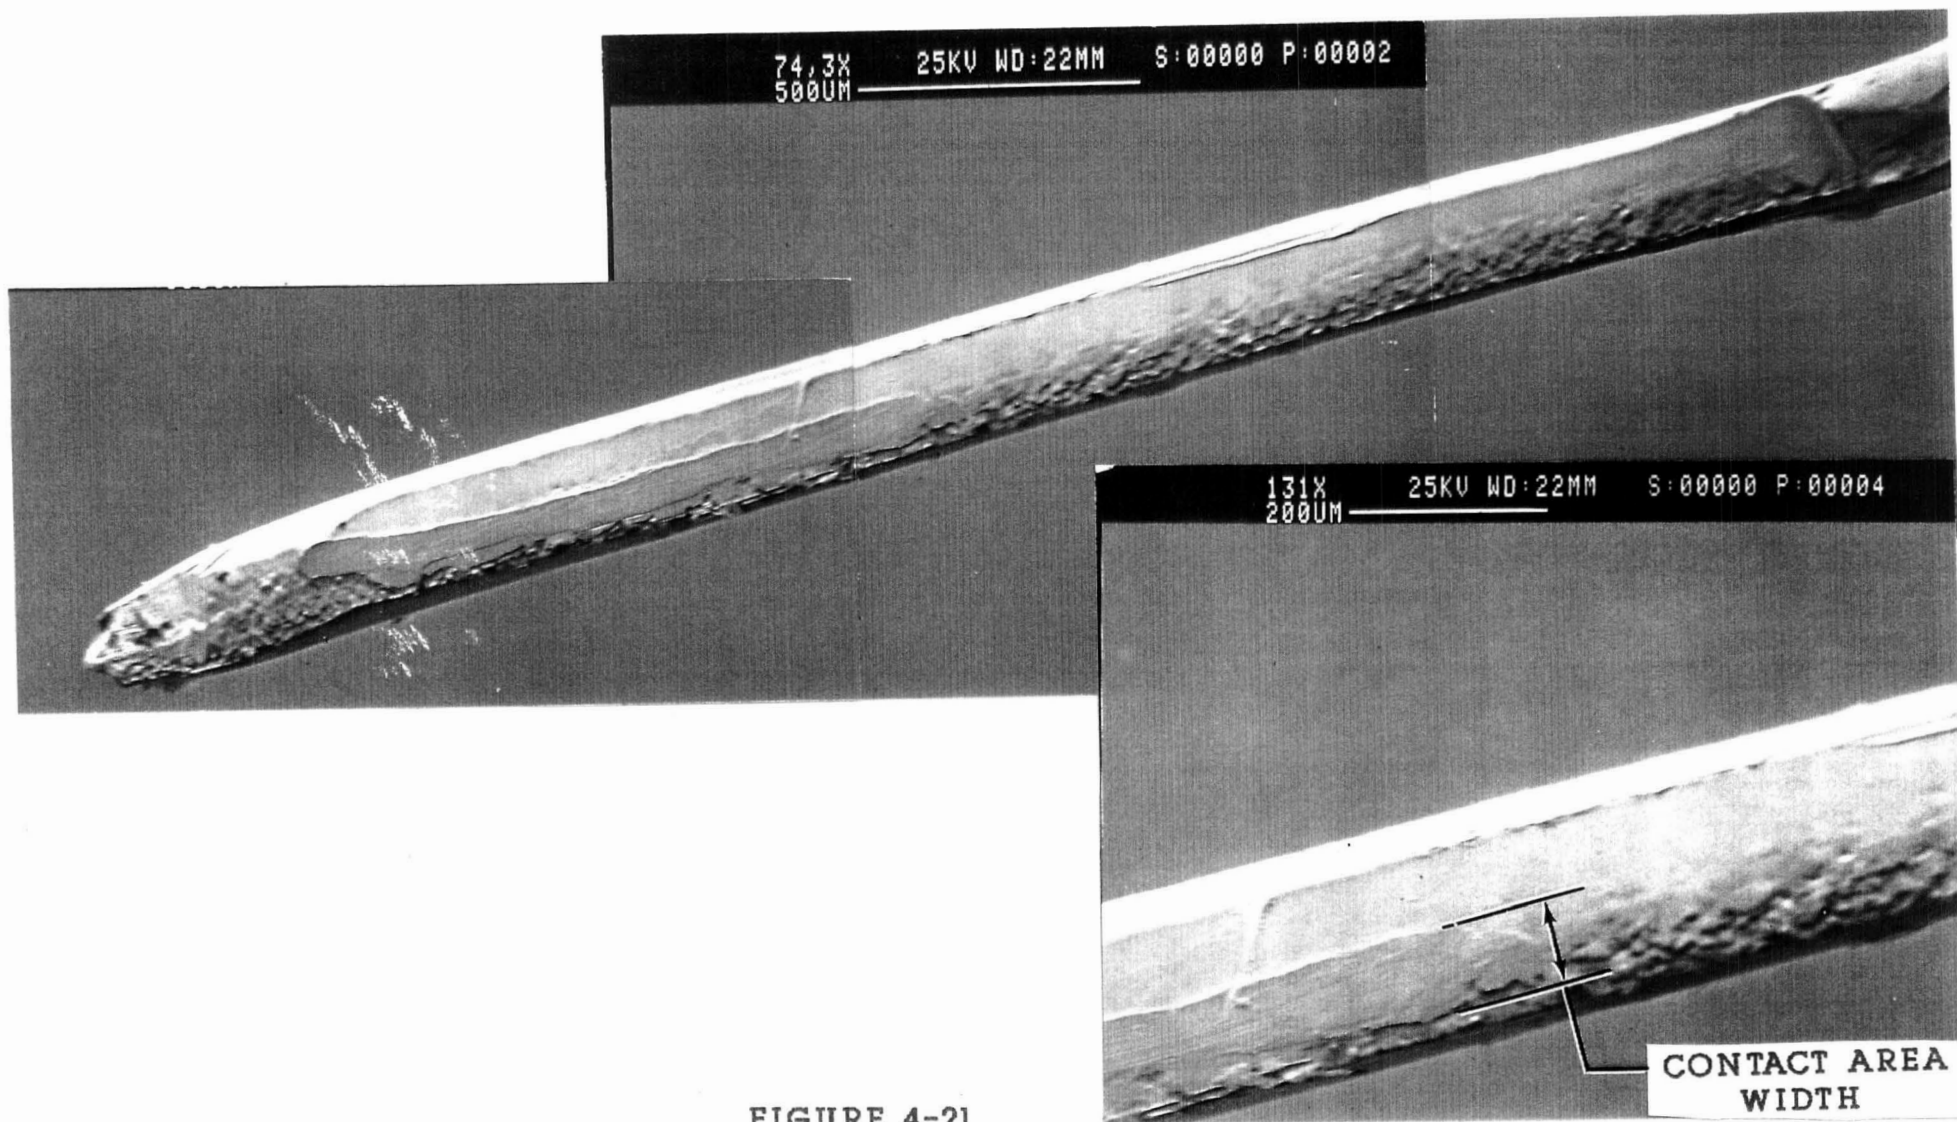
FIGURE 4-21

SEM- PHOTOMICROGRAPHS OF Ag PLATED PIN CONTACT AREA (ARROW) OF AN IC FROM BOARD NO. 1. THE SURFACE AREA APPEARS ROUGH OVER THE LOWER HALF OF THE FACE. THE WIDTH OF THE CONTACT AREA IS LESS THAN HALF OF THE PIN THICKNESS ( LOWER VIEW).

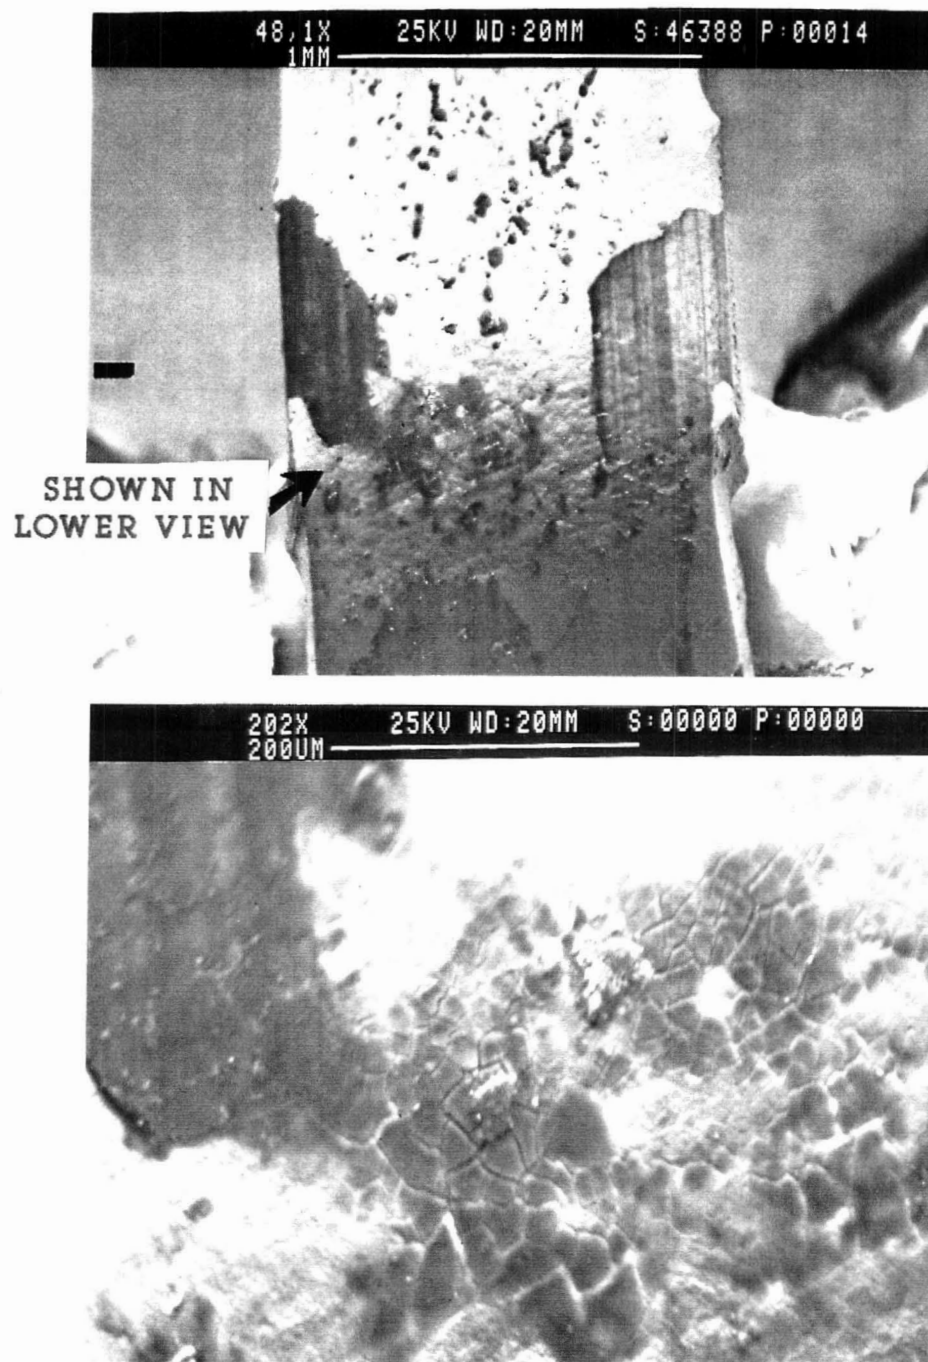
FIGURE 4-22

- 4.8.4 A second IC from Board No. 1, Model SN7495AN, BS7349, was selected for SEM/EDS analysis and documentation. The pins were a Ni-steel with Ag plating. There were numerous black areas and spots on the pins (see Figure 4-22). The areas of black have a high Si content. It was noted that the S content was much less than on other Ag plated IC pins previously analyzed. In the bend area an "orange peel" or "mud cracking" was evident through the thin Ag plating (see Figure 4-22). This is considered typical of stress corrosion. The contact area surfaces (see Figure 4-23) showed a distinct variation across the surface. This may be associated with the stamping process which formed the pins and/or the plating process. This variation appears to reduce the pin/socket contact area in the case of the black body sockets. Si and Cl were found in the pin contact areas.

SEM-PHOTOMICROGRAPH OF A Ag PLATED PIN OF IC SN7495N, 7349, BOARD NO. 1. THE DARK PITS (VOIDS) HAVE A HIGH S1 CONTENT. THE 'ORANGE PEEL' OR 'MUD CRACKING' EFFECT VIEWED THROUGH THE THIN PLATING (LOWER VIEW) IS INDICATIVE OF CORROSION.

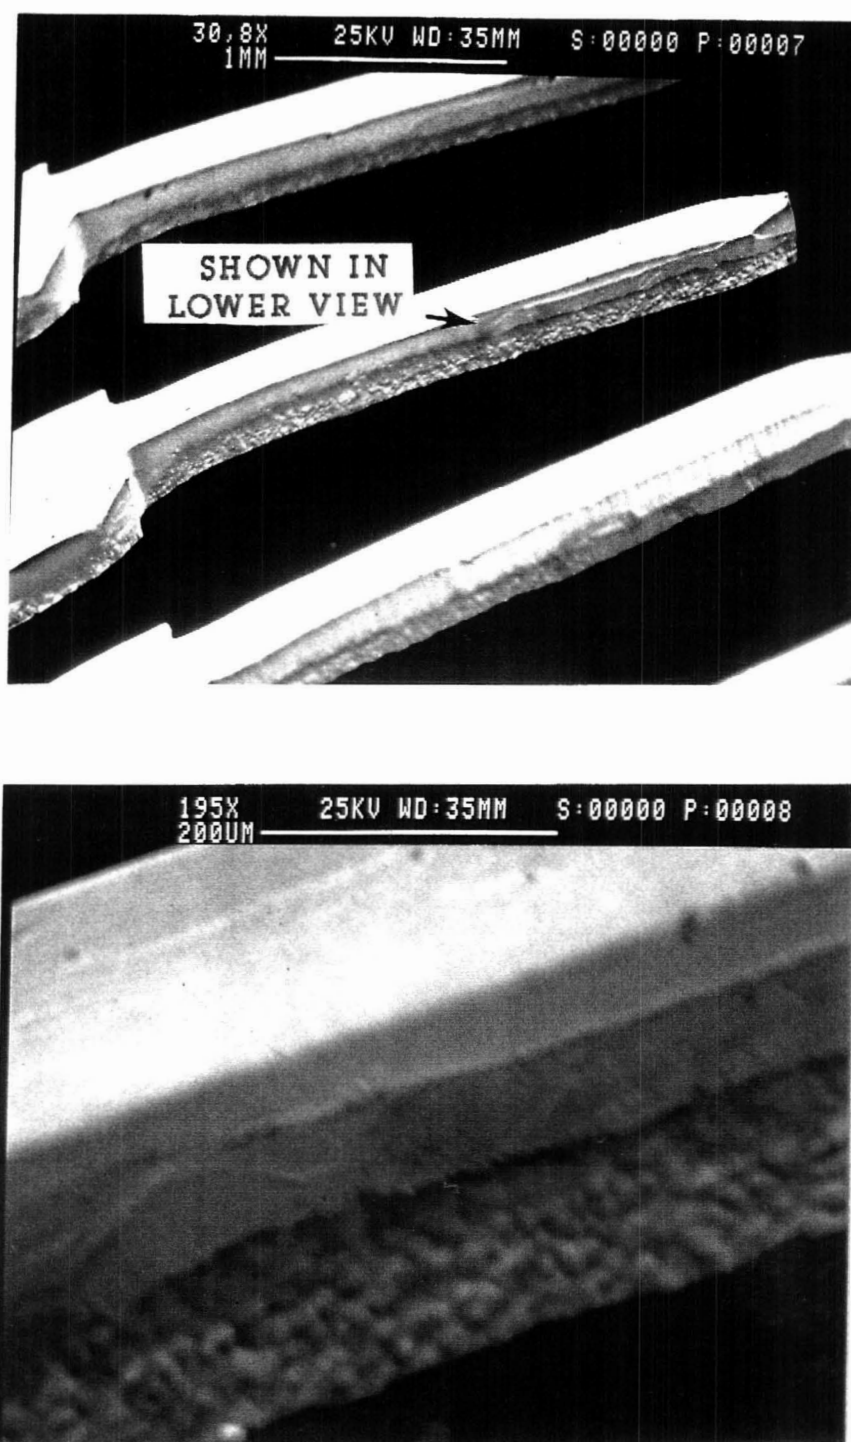
FIGURE 4-23

SEM-PHOTOMICROGRAPHS OF AN Ag PLATED PIN CONTACT AREA (ARROW) OF IC SN7495N, 7349, BOARD NO. 1. THE CONTACT AREA WIDTH IS SIGNIFICANTLY LESS THAN HALF OF THE PIN THICKNESS.

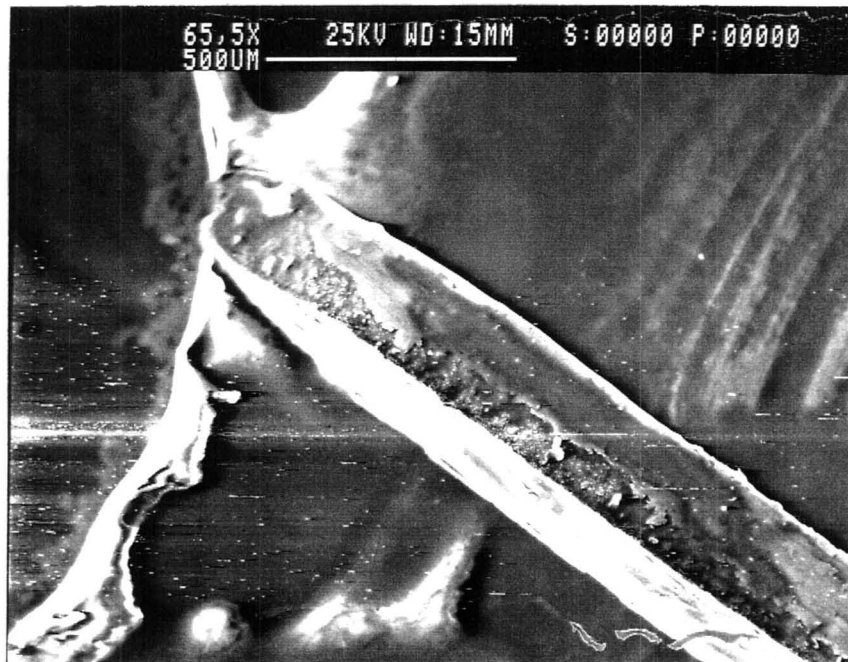
FIGURE 4-24

- 4.8.5 The IC's of this last model and manufacture date (SN7495AN, BS7349) were selected for the environmental test described in Section 5.3. This batch of IC's was selected for the apparent thin Ag plating and the anomalous, minimal contact areas of the pins which should produce a worst case environmental test conditon.
- 4.8.6 Other IC's such as the Z80's (Reference Section 4.5) have pin contact areas similar to the last IC pins analyzed (see Figure 4-23).
- 4.8.7 An IC with Sn plated pins was also found to have distinct variation in the surface profile across the contact area (see Figure 4-24).

SEM-PHOTOMICROGRAPHS OF A Sn PLATED PIN CONTACT SURFACE OF IC SN74H04N, 7949, BOARD NO. 2. THE CONTACT EDGE SHOWS A DISTINCT VARIATION IN THE SURFACE PROFILE SIMILAR TO SOME OF THE Ag PLATED PINS.

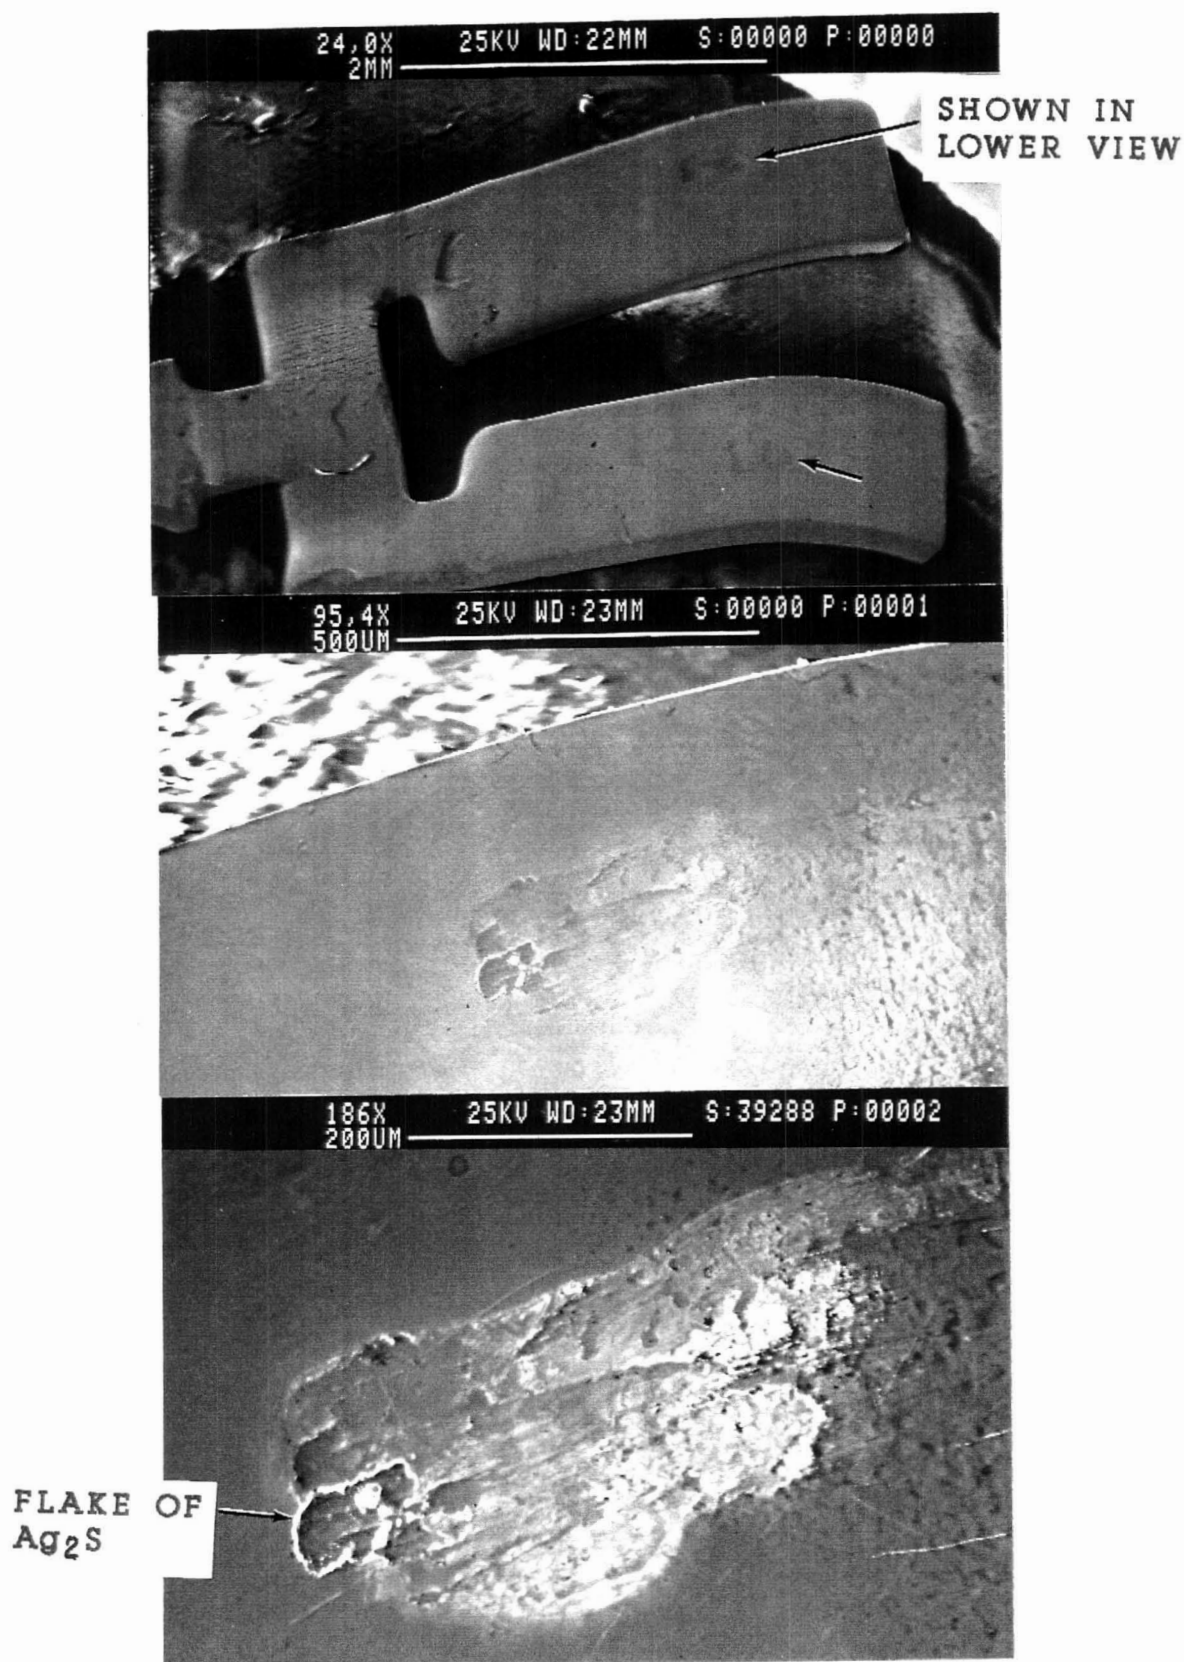
FIGURE 4-25

- 4.9.1 The Board No. 1 socket contact area examined (see Figure 4-25) had a build-up of Ag over the Au plating. A flake of  $\text{Ag}_2\text{S}$  was found in the edge of the contact area. The EDS analysis indicated that the Au plating was undisturbed and free of porosity.

SEM-PHOTOMICROGRAPH OF AN OPENED SOCKET CLIP (TOP VIEW) FROM BOARD NO. 1. THE PIN CONTACT AREAS ARE IDENTIFIED (ARROWS). THE CONTACT AREA (LOWER VIEWS) IS PRIMARILY A DEPOSIT OF  $\text{Ag}$ , WITH SOME FLAKES OF  $\text{Ag}_2\text{S}$ .

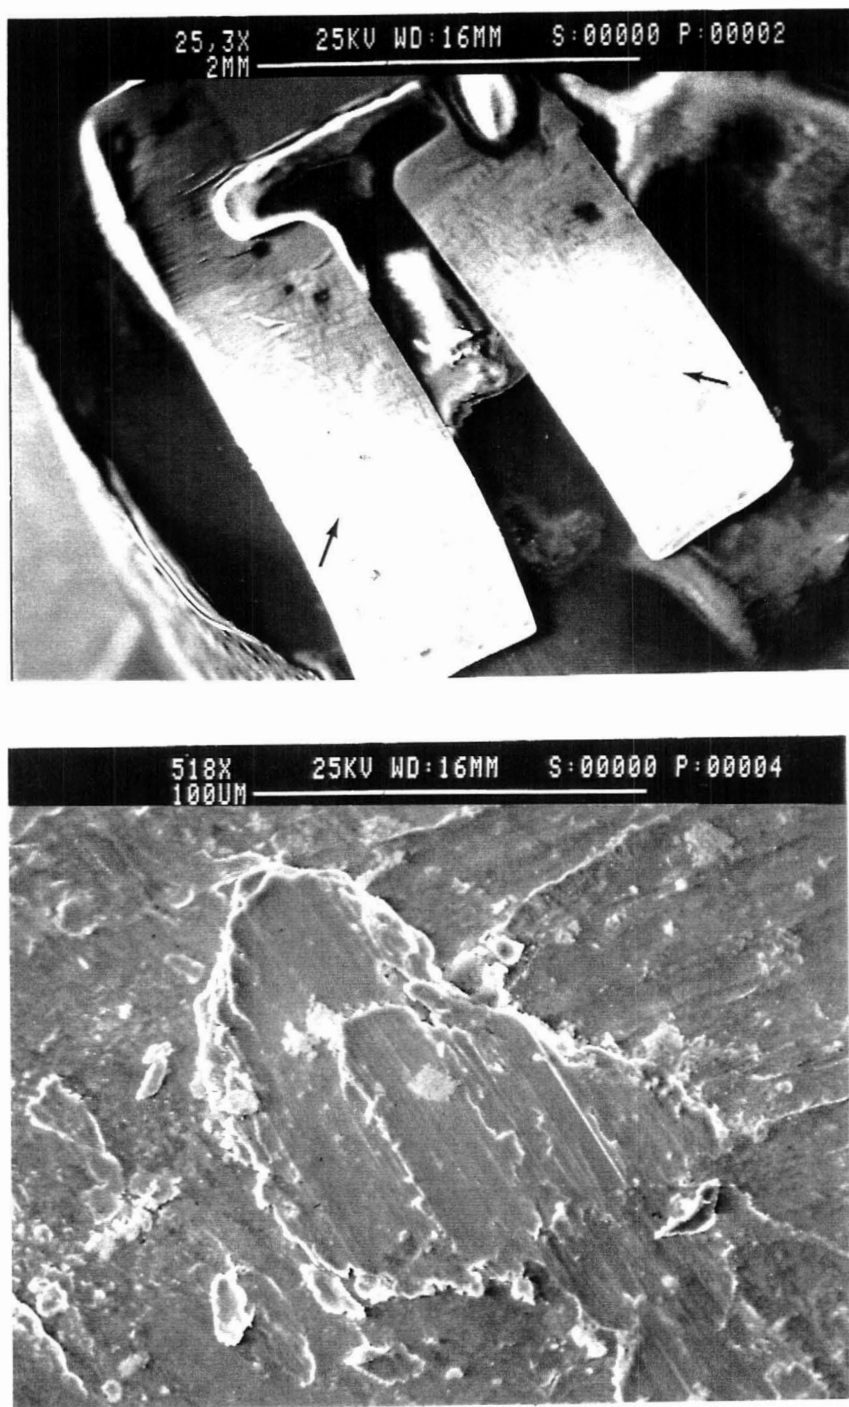
FIGURE 4-26

- 4.9.2 The Board No. 2 socket contact area examined (see Figure 4-26) had a build-up of Sn over the Au plating. The socket is Cu with Au plating over a Ni flashing. There was a significant indication of the Ni, but no Cu in the contact area, which indicates that the Au was smeared. The presence of Ag suggests that a Ag plated IC pin had once been inserted into the socket. A white material found in several locations at or near the contact area was high in oxides of Sn.

SEM-PHOTOMICROGRAPH OF AN OPENED SOCKET CLIP (TOP VIEW) FROM BOARD NO. 2. THE PIN CONTACT AREAS ARE IDENTIFIED (ARROWS). THE CONTACT AREA (LOWER VIEW) IS PRIMARILY A DEPOSIT OF Sn, WITH SOME PARTICLES OF SnO<sub>2</sub>.

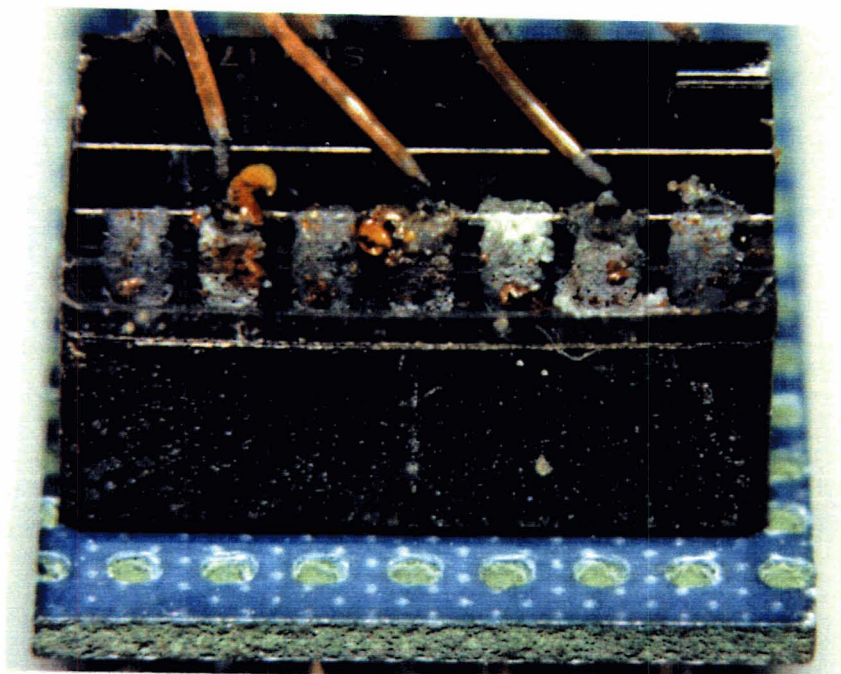
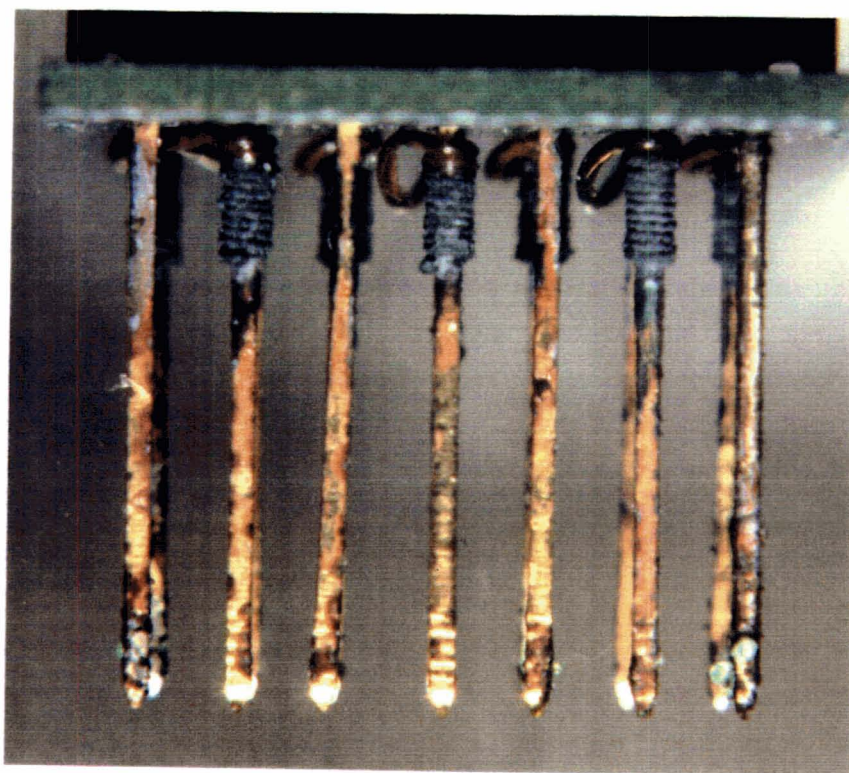
FIGURE 5-2

5.2.2.1 The Ag plated pins of the ABT1 IC were covered with a blackish-gray layer with some reddish-brown corrosion products showing through. The wire-wraps were covered with a gray coating, and some areas of the posts were also covered with a gray-green material (see Figure 5-2).

THE ABT1 IC AND SOCKET (TOP VIEW), AND THE SOCKET POSTS AND WIRE-WRAP (LOWER VIEW) ARE SHOWN AFTER 30 DAYS EXPOSURE TO A HUMID  $H_2S$  ENVIRONMENT. THE IC PINS WERE COVERED WITH A BLACKISH-GRAY LAYER WITH SOME REDDISH-BROWN CORROSION PRODUCTS SHOWING THROUGH. THE WIRE-WRAP WERE COVERED WITH A GRAY COATING, AND SOME AREAS OF THE POSTS WERE ALSO COVERED WITH A GRAY-GREEN MATERIAL.

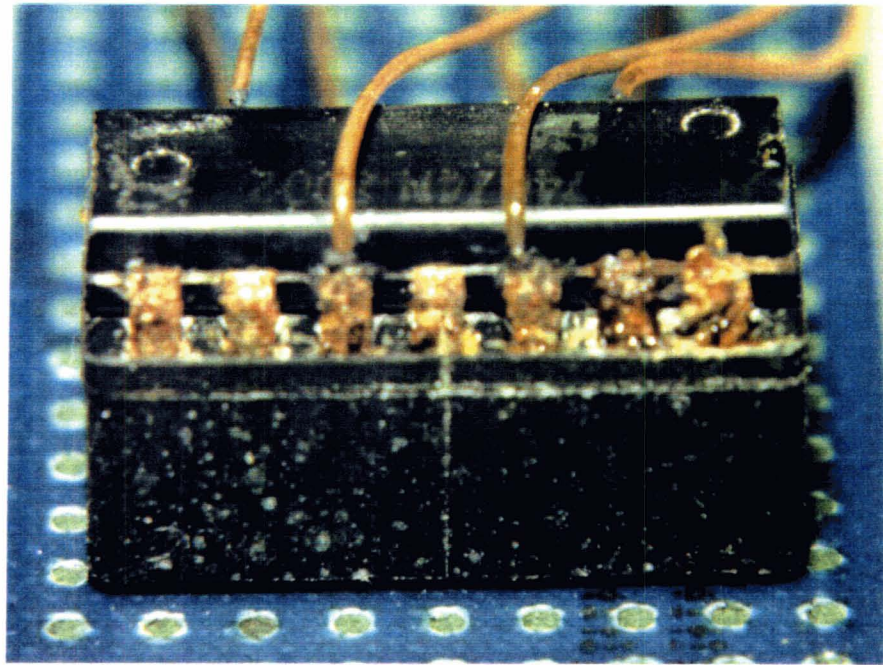
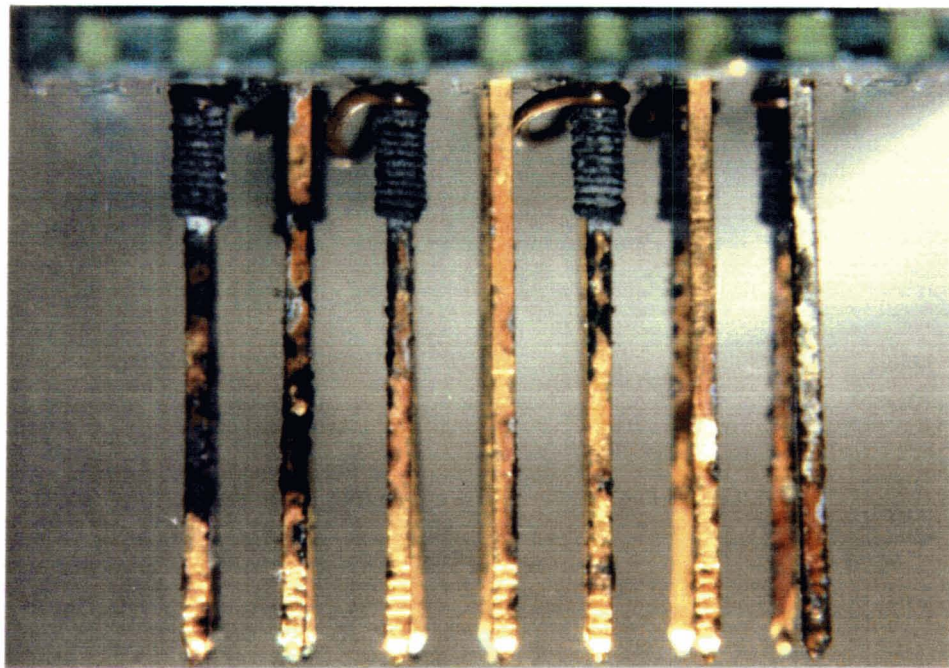
FIGURE 5-3

5.2.2.2 The Sn plated pins of the ABT2 IC were covered with reddish-brown corrosion products. The wire-wrap wires and posts appeared similar to those of ABT1 (see Figure 5-3).

THE ABT2 IC AND SOCKET (TOP VIEW), AND THE SOCKET POSTS AND WIRE-WRAPs (LOWER VIEW) ARE SHOWN AFTER 30 DAYS EXPOSURE TO A HUMID  $H_2S$  ENVIRONMENT. THE IC PINS WERE COVERED WITH REDDISH-BROWN CORROSION PRODUCTS. THE WIRE-WRAPs WERE COVERED WITH A GRAY COATING, AND SOME AREAS OF THE POSTS WERE ALSO COVERED WITH A GRAY-GREEN MATERIAL.

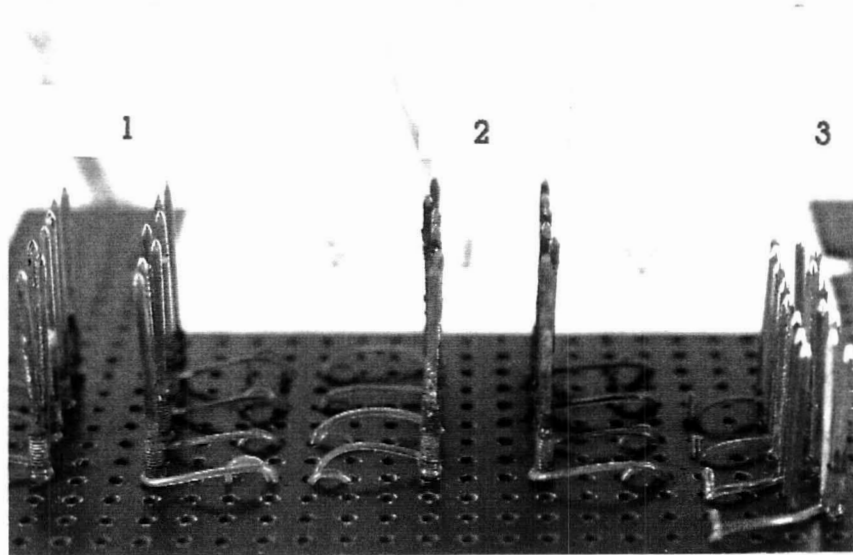
FIGURE 5-5

5.3.8 The high resistance circuits of Boards No. 1 and No. 2 were the results of pin to socket contact resistance. The wire-wrap post to wire-wrap resistances were in the range of 110 to 120 milliohms.

THE BOARD NO.2 SOCKET POSTS (CENTER) ARE CORRODED AFTER 12 DAYS OF ENVIRONMENTAL TESTING. THE ADJACENT Au PLATED POSTS (BOARDS NO. 1 AND 3) ARE UNEFFECTED.
